# S-Former Control Equipment

## Recommendations of preventive maintenance and renewal

# Proposal for preventive maintenance and upgrades

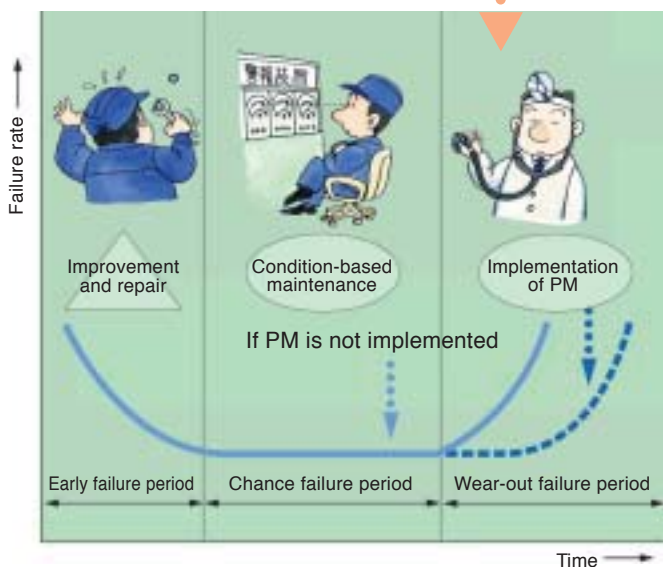
Preventive maintenance (PM) makes significant contributions when the equipment enters into the deterioration failure period of the bath-tub curve.

Implementing PM will result in:

- Prevention of failure
- Prevention of deterioration
- Life extension.

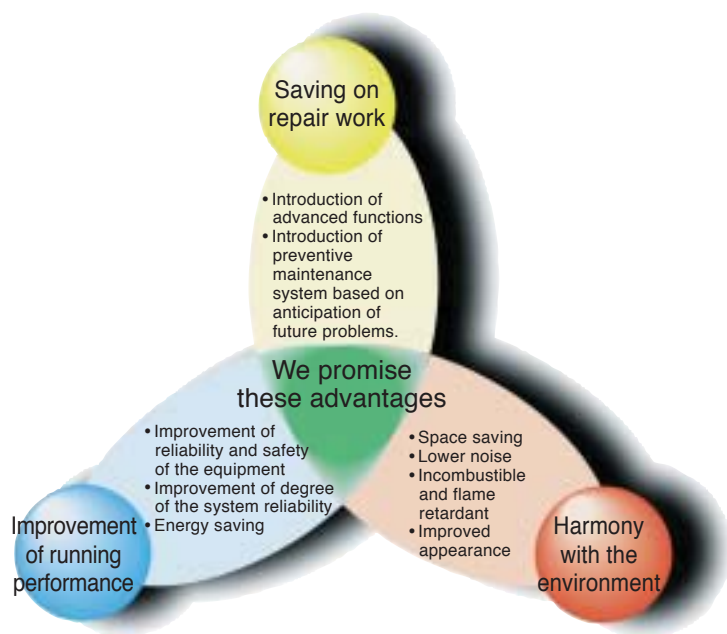
The upgrading of deteriorated electric equipment and/or facilities will not only help lower the failure rate of the equipment/facilities, but also allow rebuilding of optimal facilities with up-to-date technology. The expected effects of upgrading are shown below.

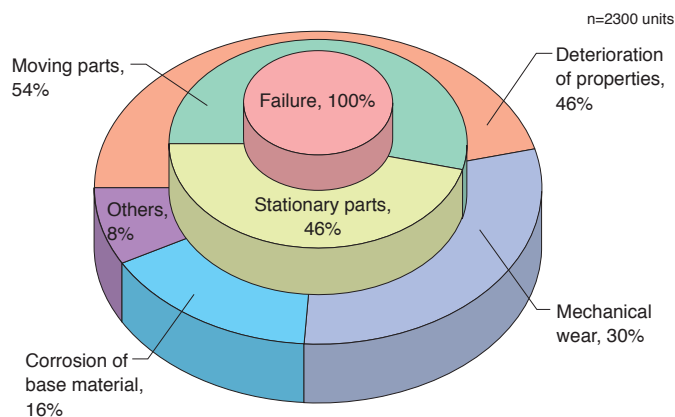
## Classification of parts failures

According to failure mode analysis, parts tend to break down due to wear and/or deterioration.

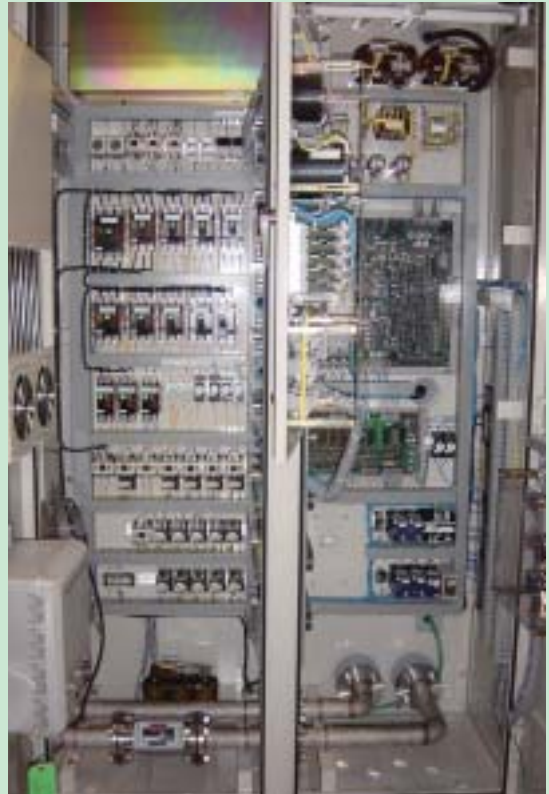
Up-to-date thyristor rectifier control panel
